⚠ CAUTION

Opening Cover could cause Electrical Shock

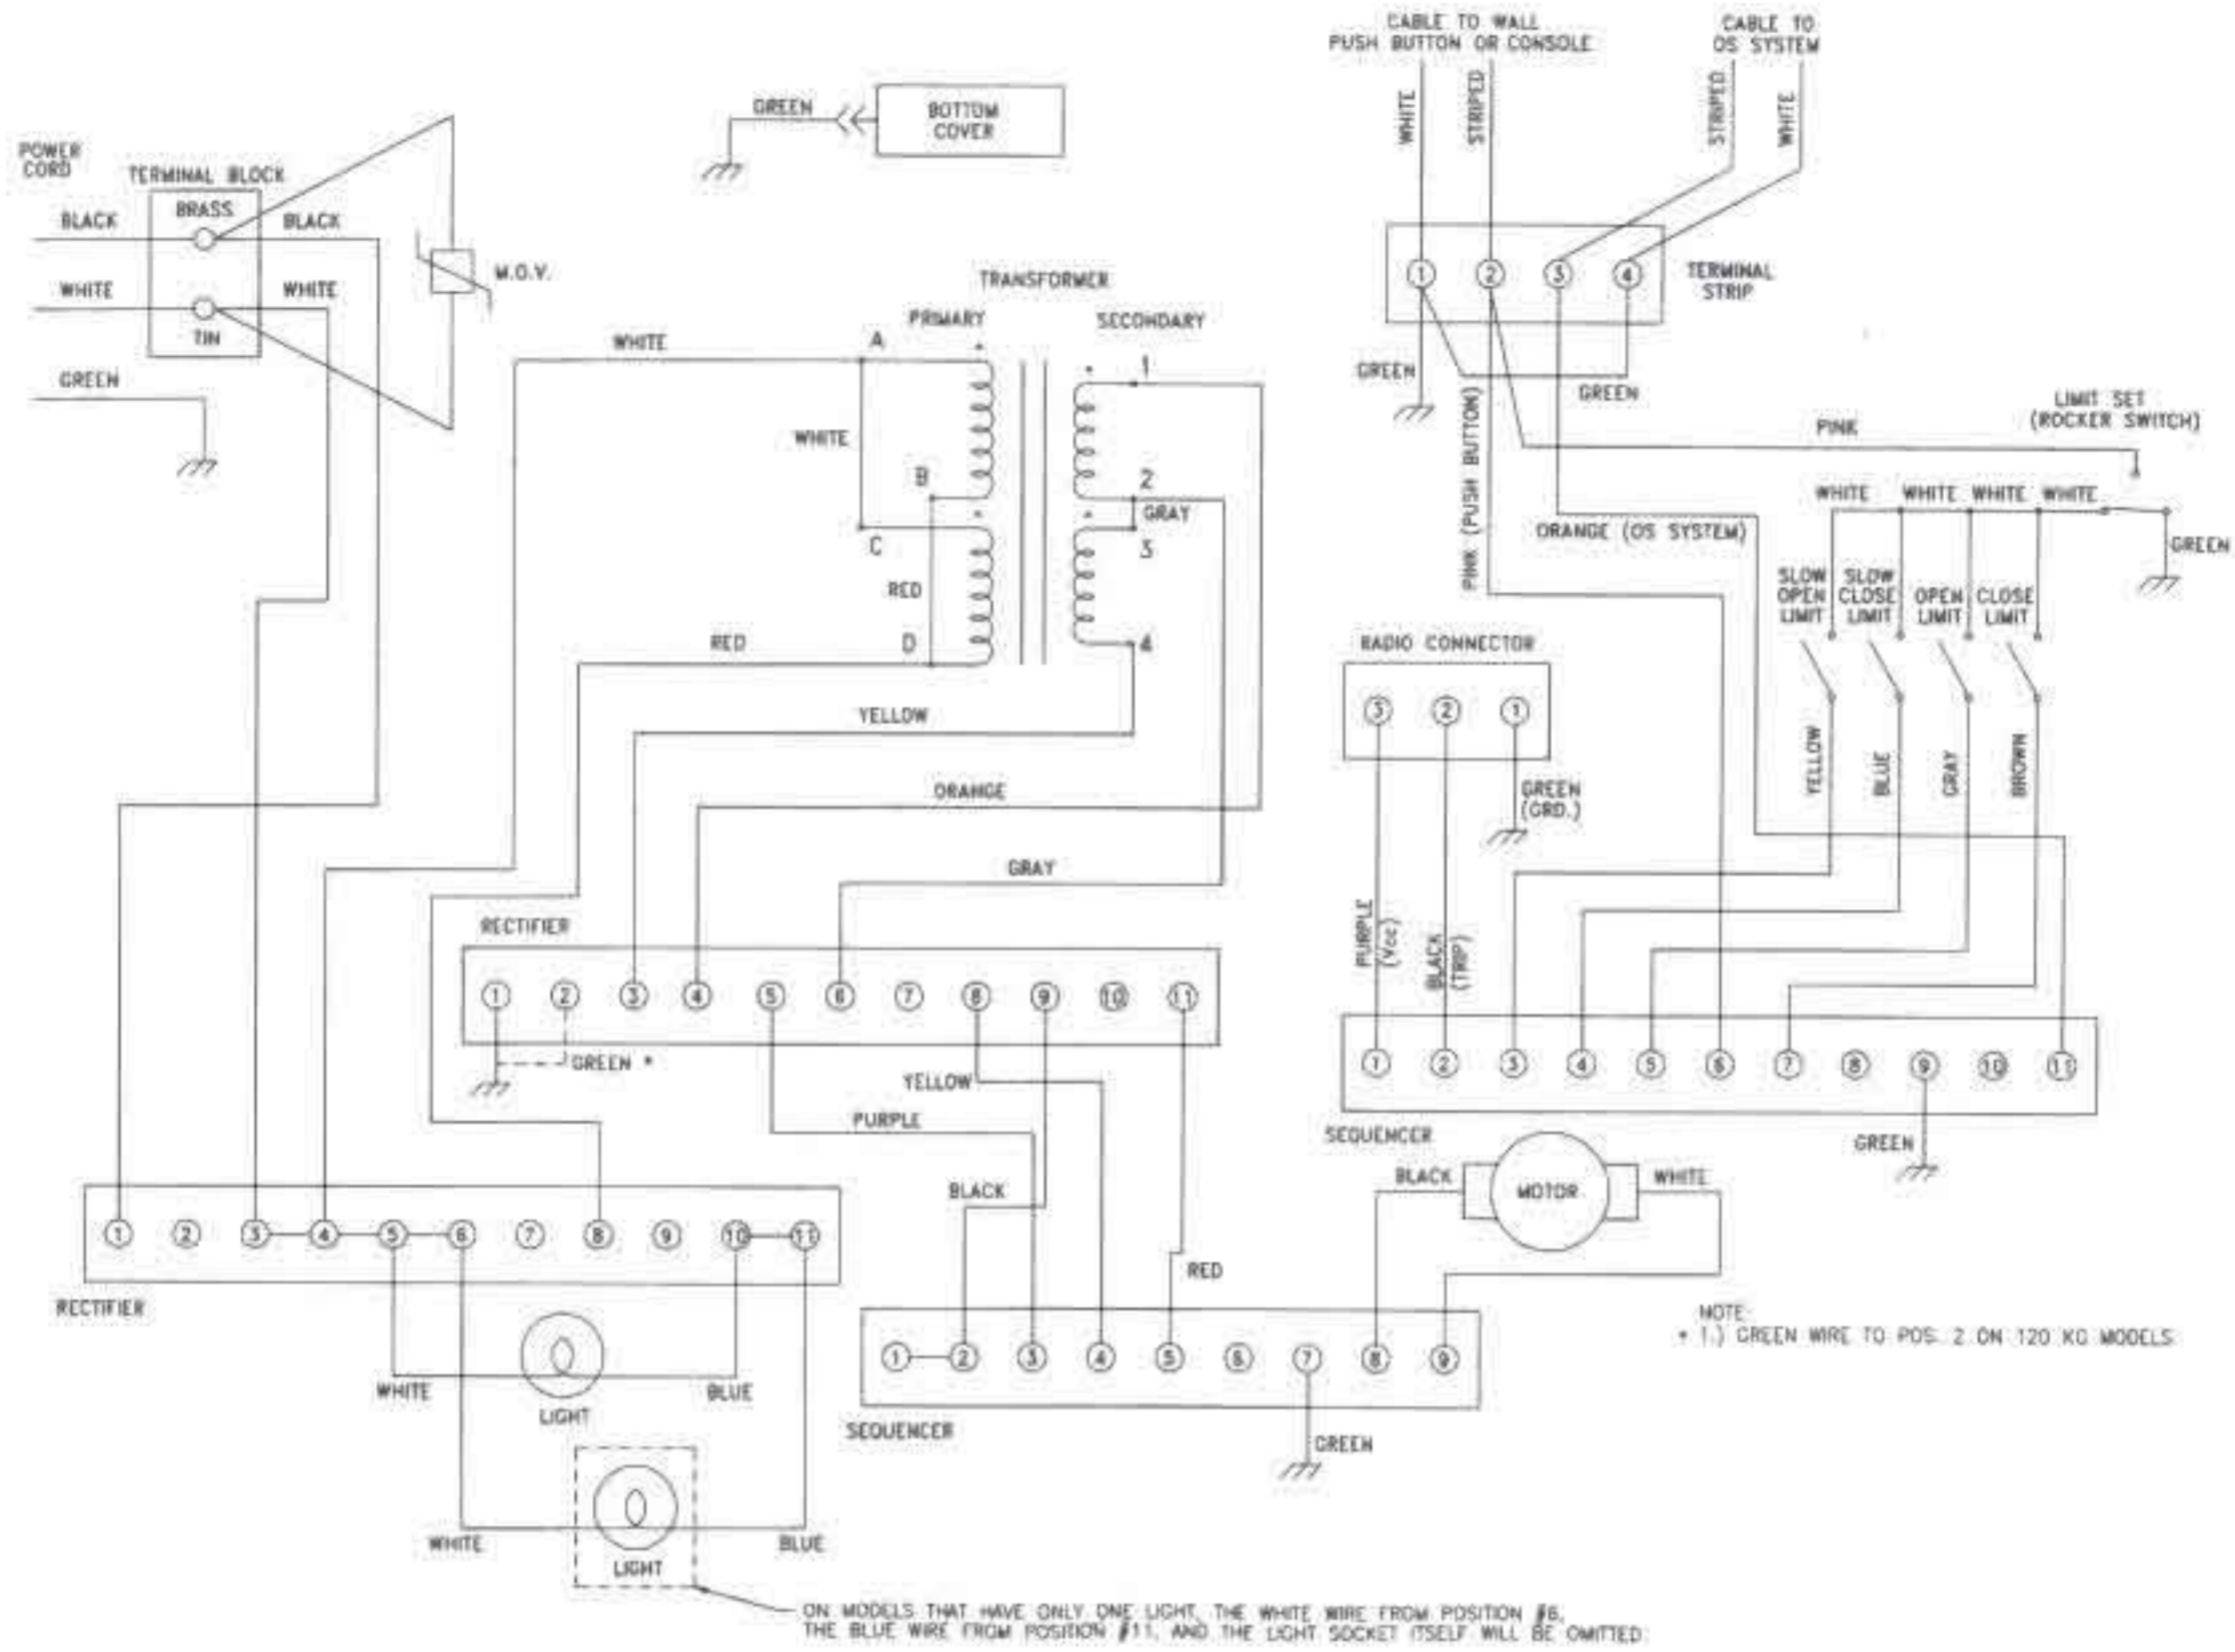
(Stealth Motor) The power cord *is* connected to an Internal Terminal Block

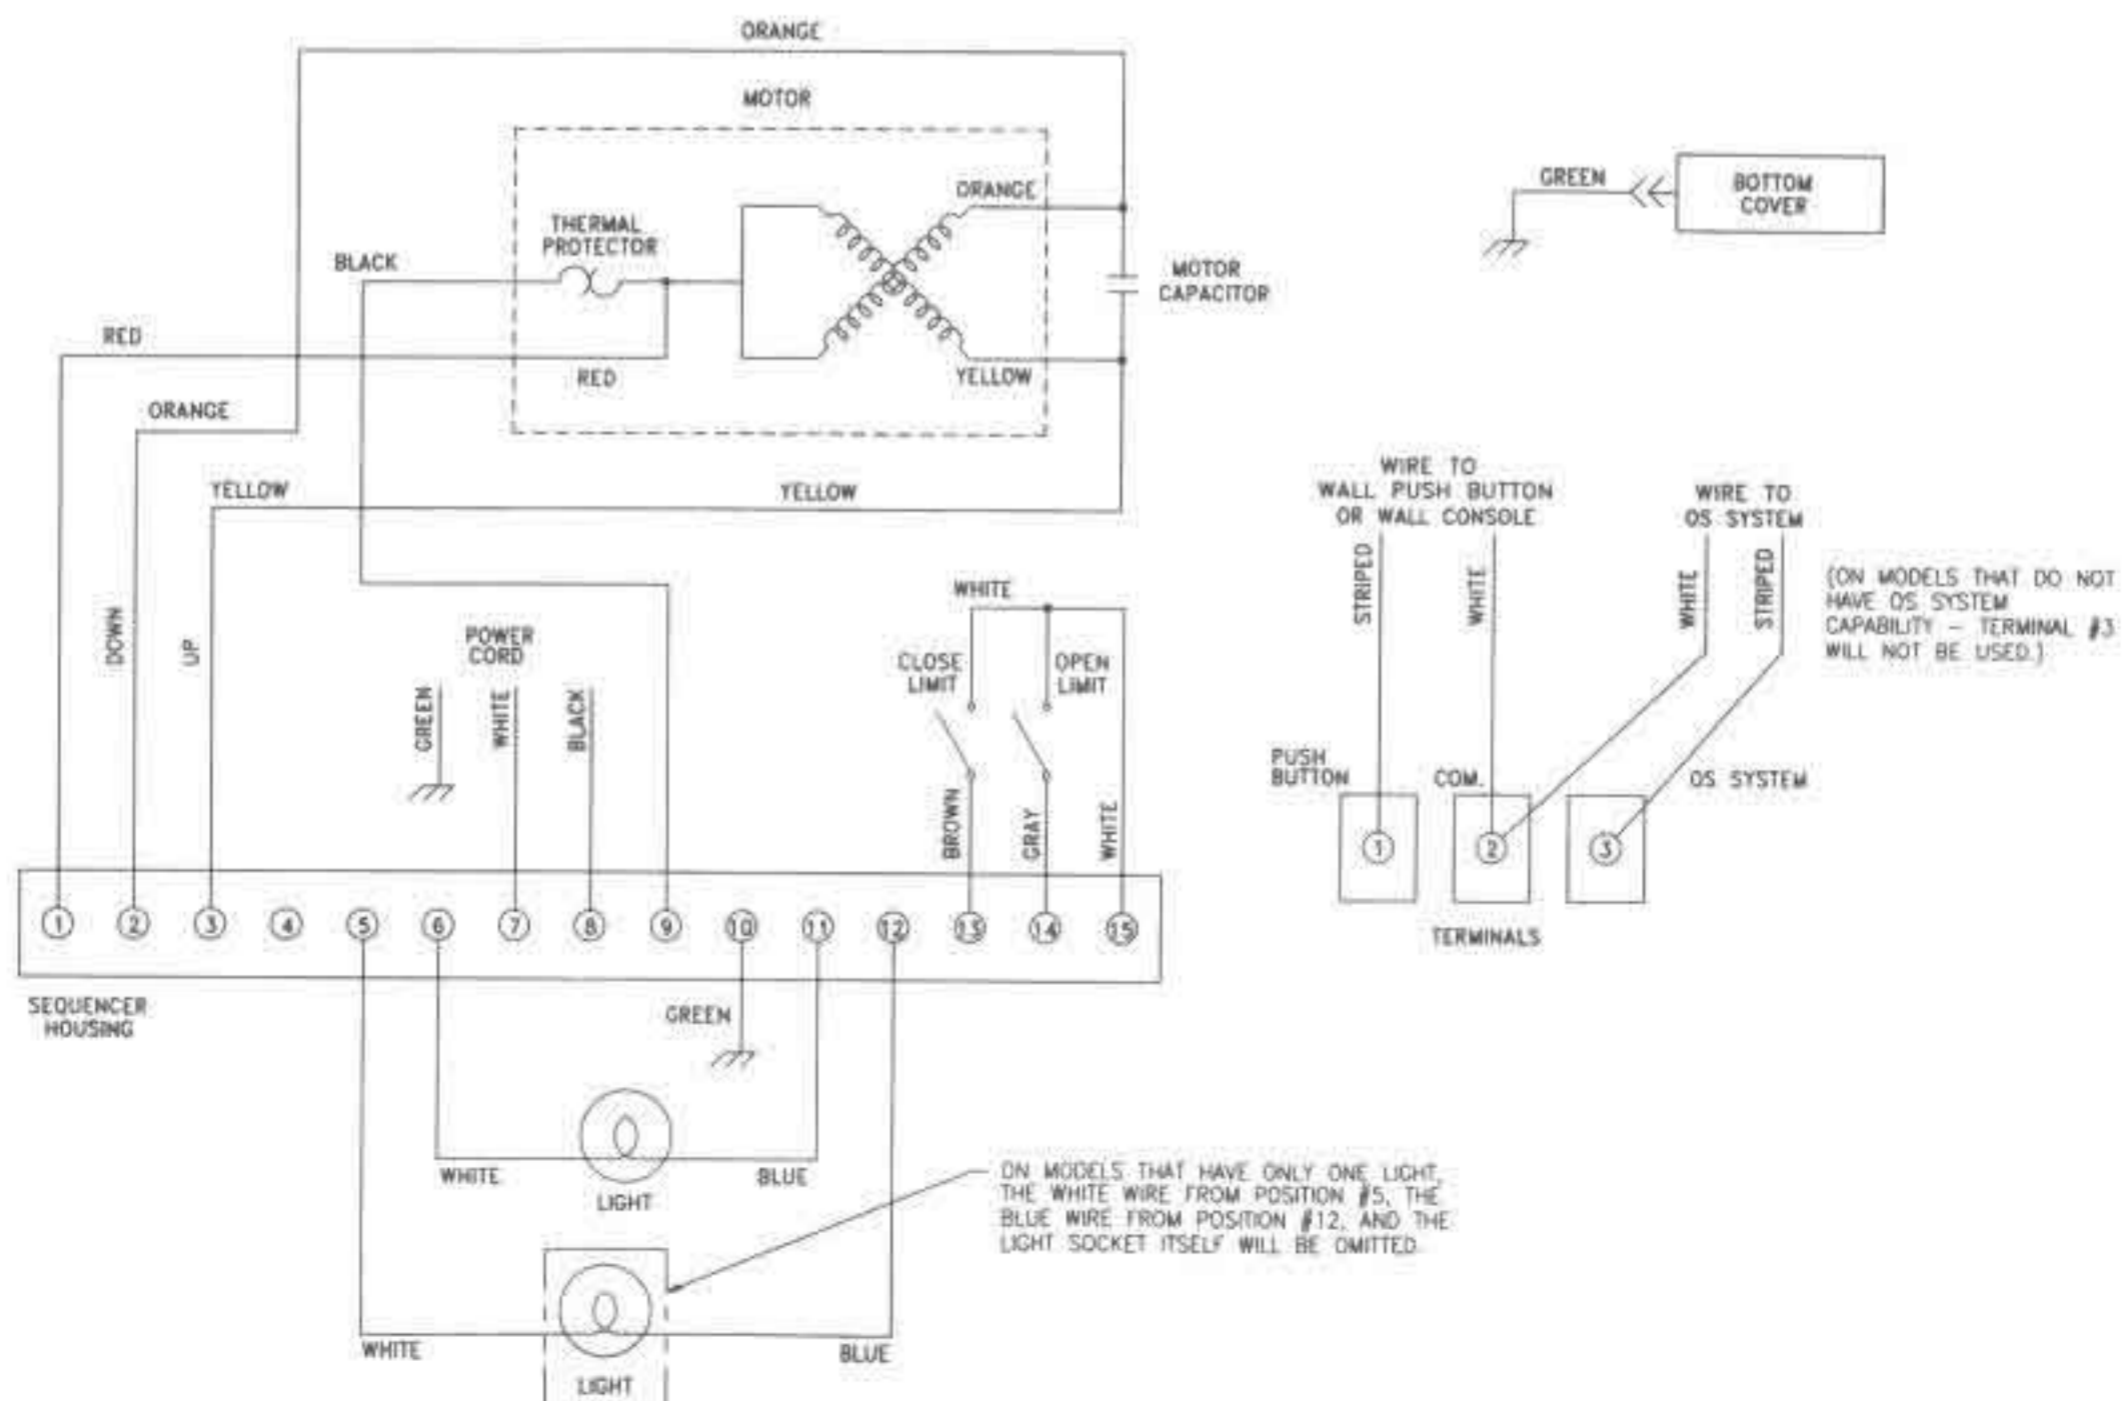
(PRO MAX Motor) The power cord *is not* connected to an Internal Terminal Block
